PROJECT OVERVIEW

This project will perform preservation work on structure 0C 286, which carries Wall Avenue over the Ogden River. Work items include structural pothole patching, overlay replacement, pin and hanger modification, and painting of the superstructure.

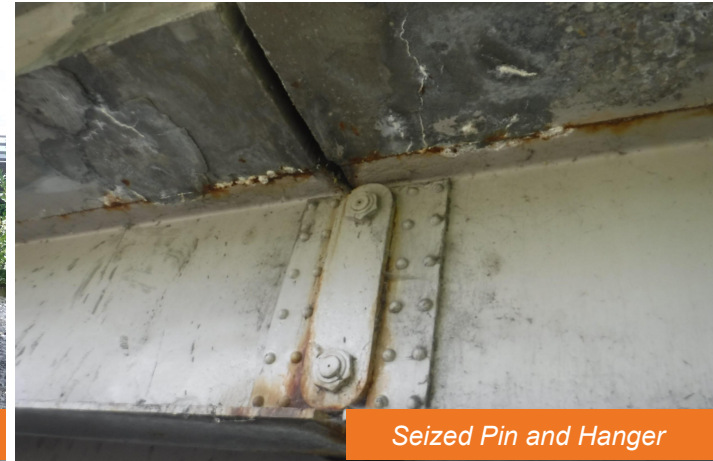
Seized Pin and Hanger

The existing pin and hanger assemblies, meant to move with seasonal expansion cycles, have seized over the years due to corrosion build up. Keeping these assemblies functioning as intended is crucial in bridge performance and durability.

These repairs will help to slow the rate of deterioration of the structure, and assist in extending the overall service life of this facility. This project will also address the safety concerns of the corroded pin and hanger assemblies, which are a fracture critical element of this bridge.
